Learning from Costa Concordia

The tragic events surrounding the grounding of the Costa Concordia provide an opportunity for maritime students to witness the potentially devastating consequences of navigational errors. The following research paper from the *University of Ljubljana, Faculty of Maritime Studies and Transport* shows how real life situations can be incorporated into maritime simulation

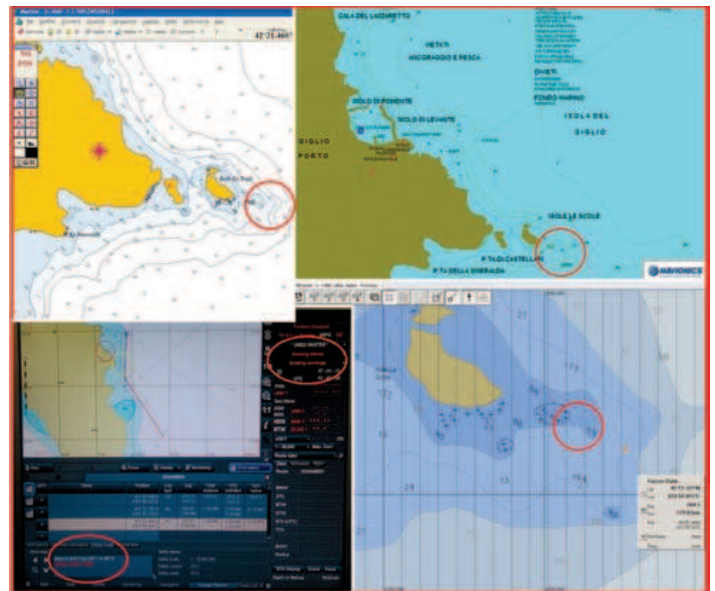
Figure 1 – Different electronic charts and the ECDIS system identify shallow water area and several alarms are activated

The captain was reported to have said that the rock or rocks the vessel hit were not on his charts. This was a good opportunity to put our students to work, having them collect as many charts of the waters off Giglio as possible.

They found that the rocks are charted on even the lowest resolution charts, and

particularly on the chart and the ECDIS system that they were actually using on the Costa Concordia. In fact, the students could not find a chart that did not clearly indicate the rocks.

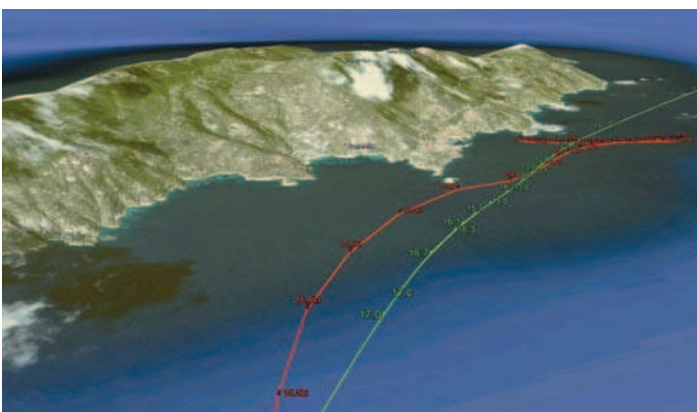
Figure 2 – Show-off passage (Green dated August 14th 2011)

Further, we found that in the last year only one (the same vessel) passenger vessel passed near the island, presumably performing a 'salute manoeuvre', but did so on what appears to be a pre-established course, aiming toward the island all the way from Civitavecchia.

The Costa Concordia, on the other hand, had plotted a course like all previous courses through the straits, only deviating as it neared a position parallel to the island.

This deviation led to a contradiction that increased the likelihood of an accident: 1) while the steering was on what is known as a 'tourist' setting - that is, as gentle a turn as possible, as people may still be dining and so on, 2) the turn required was much more acute than it would have been had the 'salute manoeuvre' route been followed (see Figure 2, previous page).

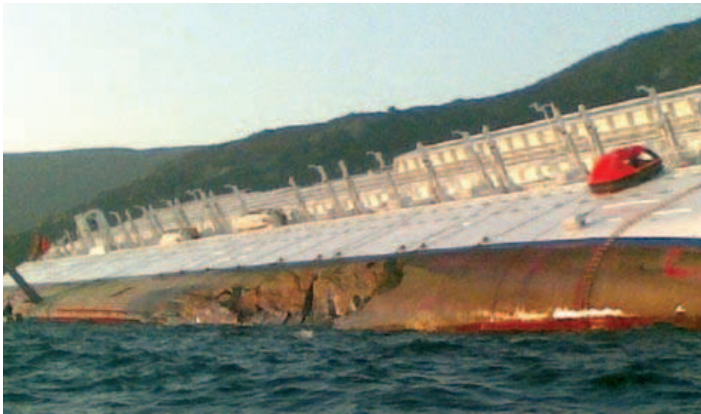
Figure 5 – Port side aperture at engine room location

Our theory is that the ship was not sinking. First of all, when we took note of the size of the hole in the hull caused by the grounding, some 40 to 50 meters max-

imum, and the location, towards the stern, it seemed likely that the ship had lost propulsion because of the flooded engine room, but that it would not have sunk – for one thing there are no transversal bulkheads in this engine room.
